## Lifting the 'Vale' on the Green Green Grass of Home

Cardiff based sports pitch design consultants GEO Turf Consulting Limited take us through the role they played in the recent construction of the new training grounds for the Football Association of Wales.

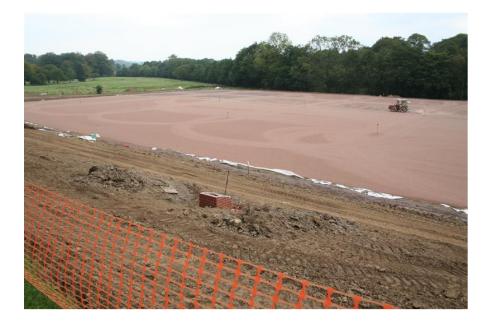
Grading of the grit drainage layer

Following the installation of the cutoff drain and the laser grading of the formation 150mm diameter carrier drains were installed around the perimeter of the area. From these drains 300mm deep lateral drains were cut to into the formation at 5.0m centers. These were then in-filled with approved 5 mm - 10 mm drainage aggregate. A separator geotextile was then placed between the drains and 150mm depth of grit was installed to form a drainage carpet across the graded formation.

A benefit of the grit layer is that if required the drainage properties of the profile can be quickly improved with verti-draining. The verti-drain will not only help to relieve any compaction present, but it will also form direct drainage channels through the pitch profile into the grit drainage layer. Fertilizer can be brushed into the holes to get the nutrients deep into the profile, and then if required, the holes can be in-filled with an approved medium fine top-dressing sand which will act as a preferential drainage pathway into the grit.

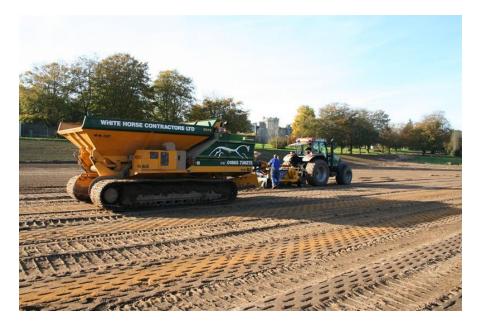
November 2006- Installation of the forced slit drainage system prior to seeding

A possible negative of having higher fines content is the potential for restricted surface drainage when the soil becomes compacted. At the Hensol castle site, to overcome this potential restriction, forced slit drains were installed at 750mm centres along the line of play. These secondary drains are 50mm wide and installed through the soil profile to a depth of 300mm into the grit drainage layer. During installation the slit drains were in-

filled with a uniform 2.0mm grit which has a high drainage capacity and flows easily through the installation equipment, even when wet. A small degree of heave is created during the installation of the forced slit drains, but this is removed with the final cultivation and surface sand dressings.

The installation of slit drains during construction results in getting the area into play in a shorter period of time, as it negates the need to disturb the playing surface following grass establishment. Also, due to the extra compression of the soils around the sides of the forced slits, the likelihood of future settlement is reduced. This in turn reduces the need for costly topping up. A benefit of the extra compression placed on the sides of the forced slits may be the reduced risk of future settlement, and the resulting need for costly topping up following construction.

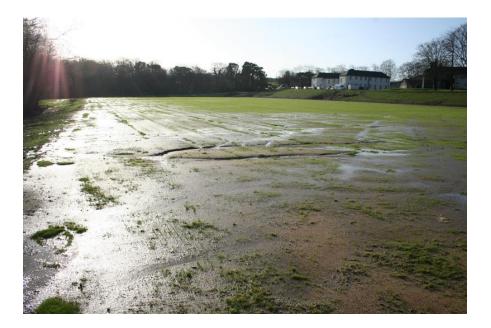
Mid January 2007. Surface in poor condition following two months of intense rainfall.

As soon as the deluge was over the site drained quickly and remedial work started immediately. A rootzone was dressed into to the washed out runoff areas and overseeding was carried out. Thankfully no more serious deluges took place and the seed germinated to enhance the existing sward. A further 6.0mm dressing of sand took place three times from April to July to ensure the integrity of the slit drains and to improve surface durability and quality of the playing surface. Following this the first vertidraining operation took place in order to get the topsoil into better condition.

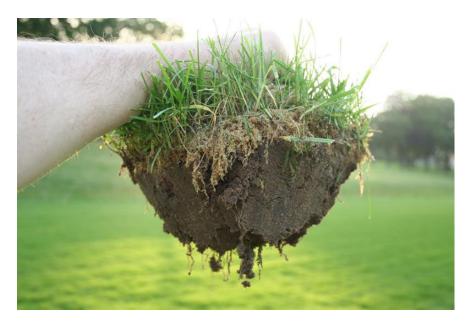
Late April 2007 and the good weather is now making a difference to sward density and rooting depth.

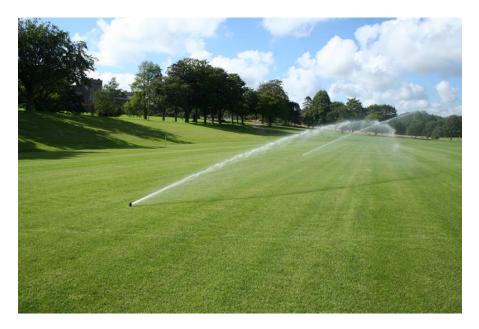
## Spring 2007 – Irrigation in full swing

water to the Hensol Estate and underground storage tanks and pumps were fortunately located close to the development area. It was simply a case of renewing the pumps and then connecting the new ring main into the mains supply pipe, which led to the castle. A total of twenty-six pop-ups were installed around the perimeter of the area and twentyfour within the pitch surface, with the electronic control panel being located in the nearby changing rooms.

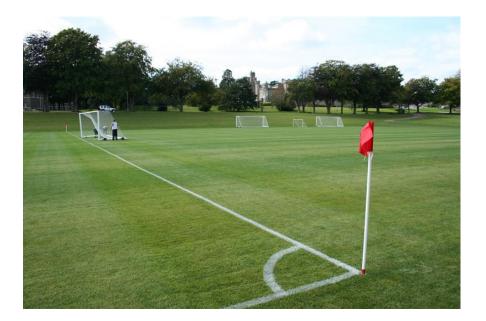
## August 2007 – Final preparation of the finished product

The pitches have recently reached full usage and look magnificent. The sward is deeply rooted and is proving very resilient to the training and the matches now taking place on it. But take our word for it, if you are lucky enough to visit The Vale Resort, please feel free to inspect the pitches. On our last visit the Welsh football squad had just finished using the area in preparation for their European Championship Qualifiers and Cardiff City FC were in full swing. They told us the pitches were ideal for their requirements. Even the goalies, seen here with Jonathan Smith (the short one), were happy, although they requested a supersoft padded area around the goalmouth so as to have more comfortable landings! You can please some of the people......"
